### INSPECTION REPORT

Project No.:	: XXXXXXXXX
Vendor Name	: XXXXXXXXX
Factory Name	: XXXXXXXXX
Factory Address	: XXXXXXXXX
Order No. / PO No.	: XXXXXXXXX
Product description:	: valve
Inspection Date:	: XXXXXXXX

The purpose of this visit is to carry out the visual, dimension inspection and hydro test for 23 items of valve listed in PO XXXX according to purchaser order and specification.

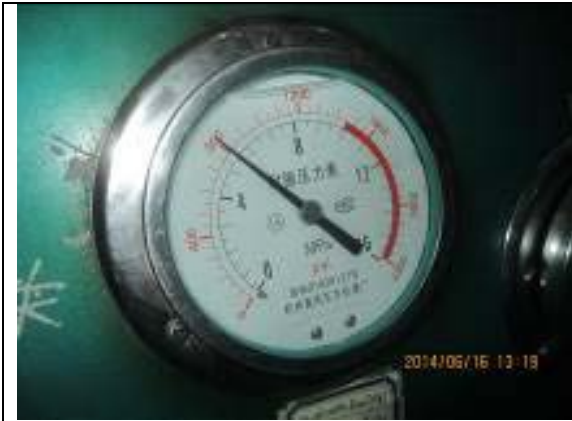
Showing the seat closure tests.

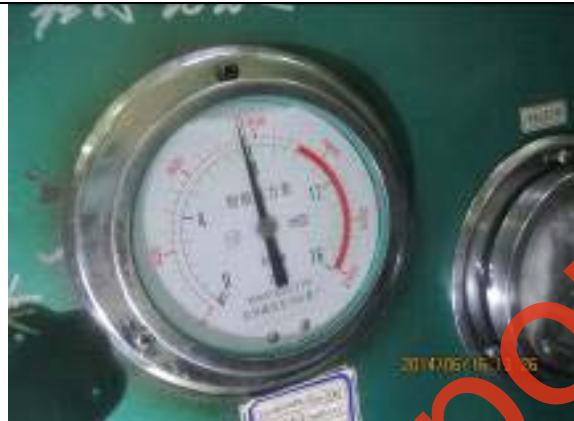
Showing the shell test.

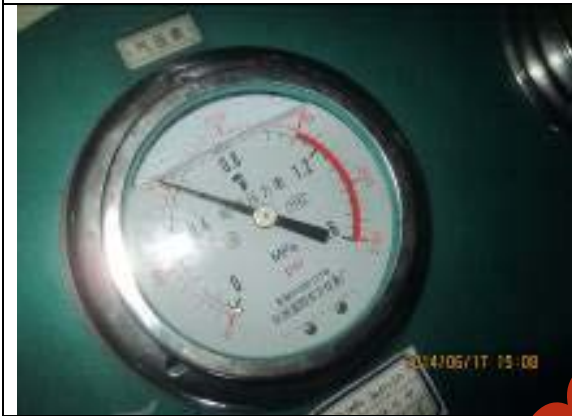
Showing the air closure test.

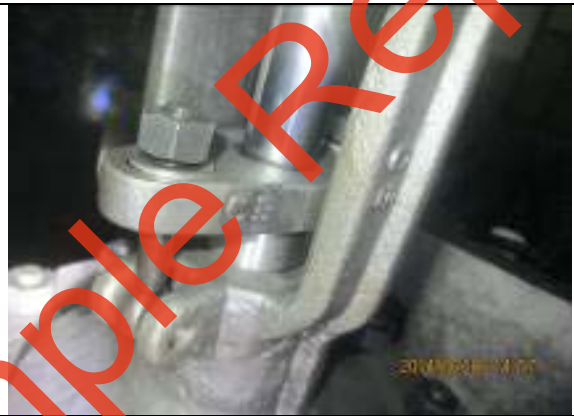
Checking leakage on backseat;

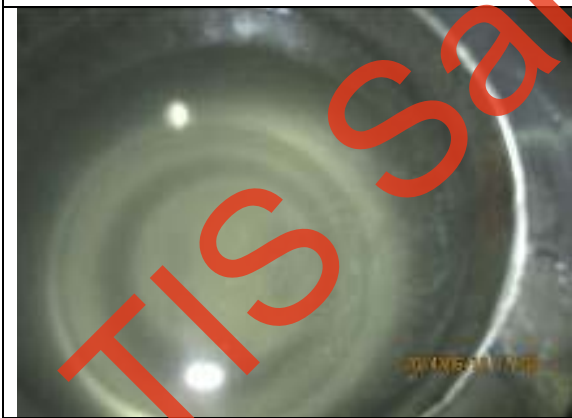
Checking leak during air closure test;

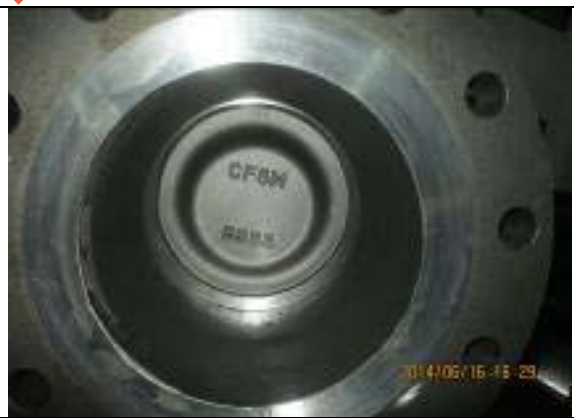
Checking leak during high seat closure tests.
